# Intel<sup>®</sup> i960<sup>®</sup> RM/RN/RS I/O Processor

*Specification Update*

*September 4, 2001*

Order Number: [273164-020](#)

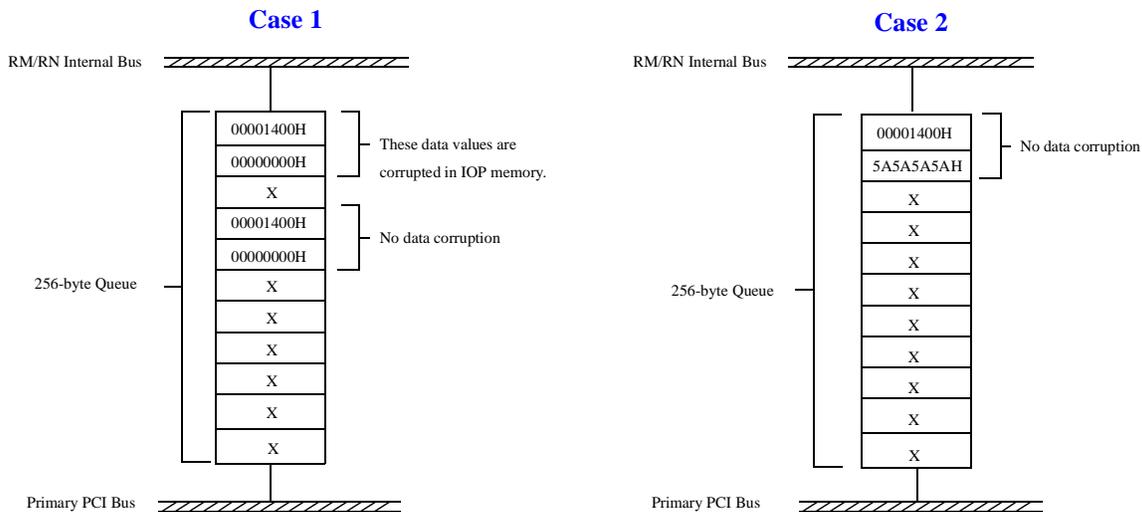
**Single Transaction on the Internal Bus**

Examples on [page 19](#) describe the error condition.

**Implication:** Data corruption results when the data value matches the MMR address range of the active DMA channel.

**Workaround:** There are two possible workarounds for this errata:

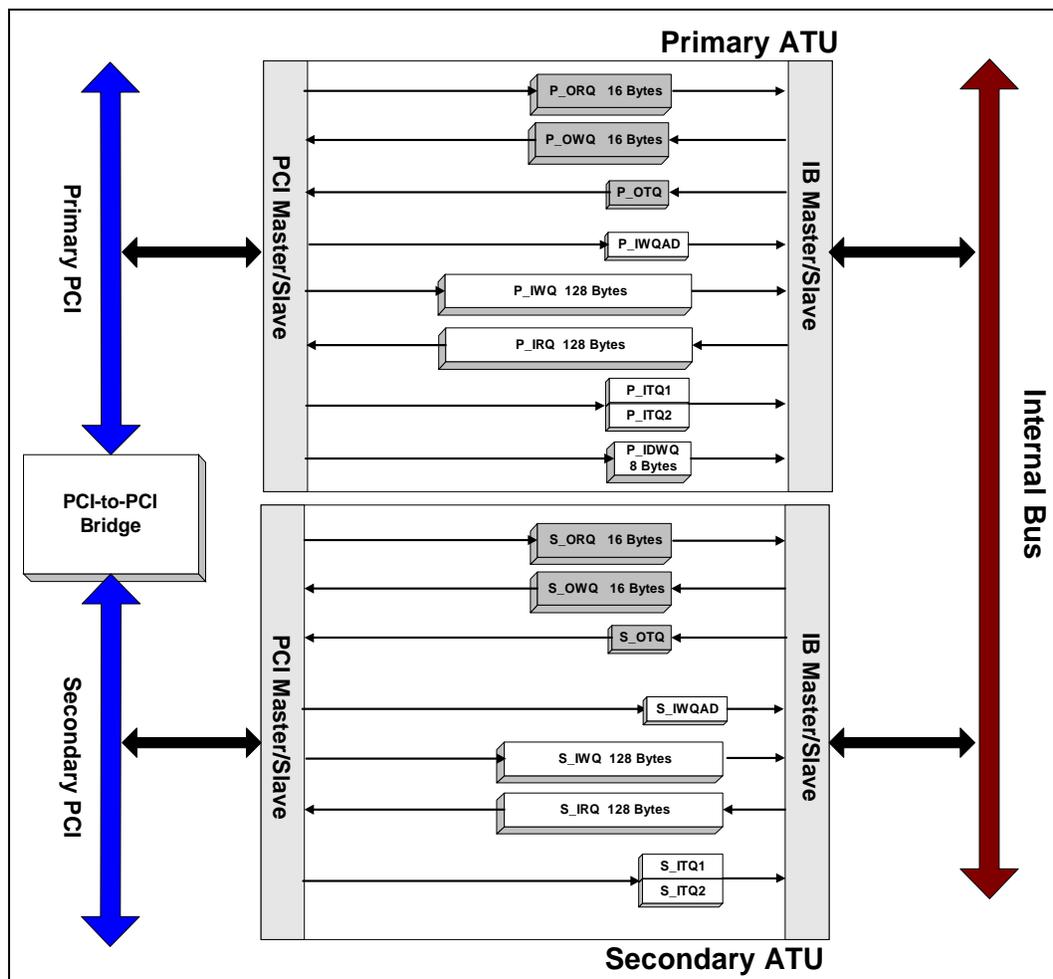
**Figure 15-2. ATU Queue Architecture Block Diagram**

**Issue:** Figure 15-2 on page 15-3 has been changed. The arrows in the box containing P\_IRQ 128 Bytes have been reversed. See Figure 15-2.

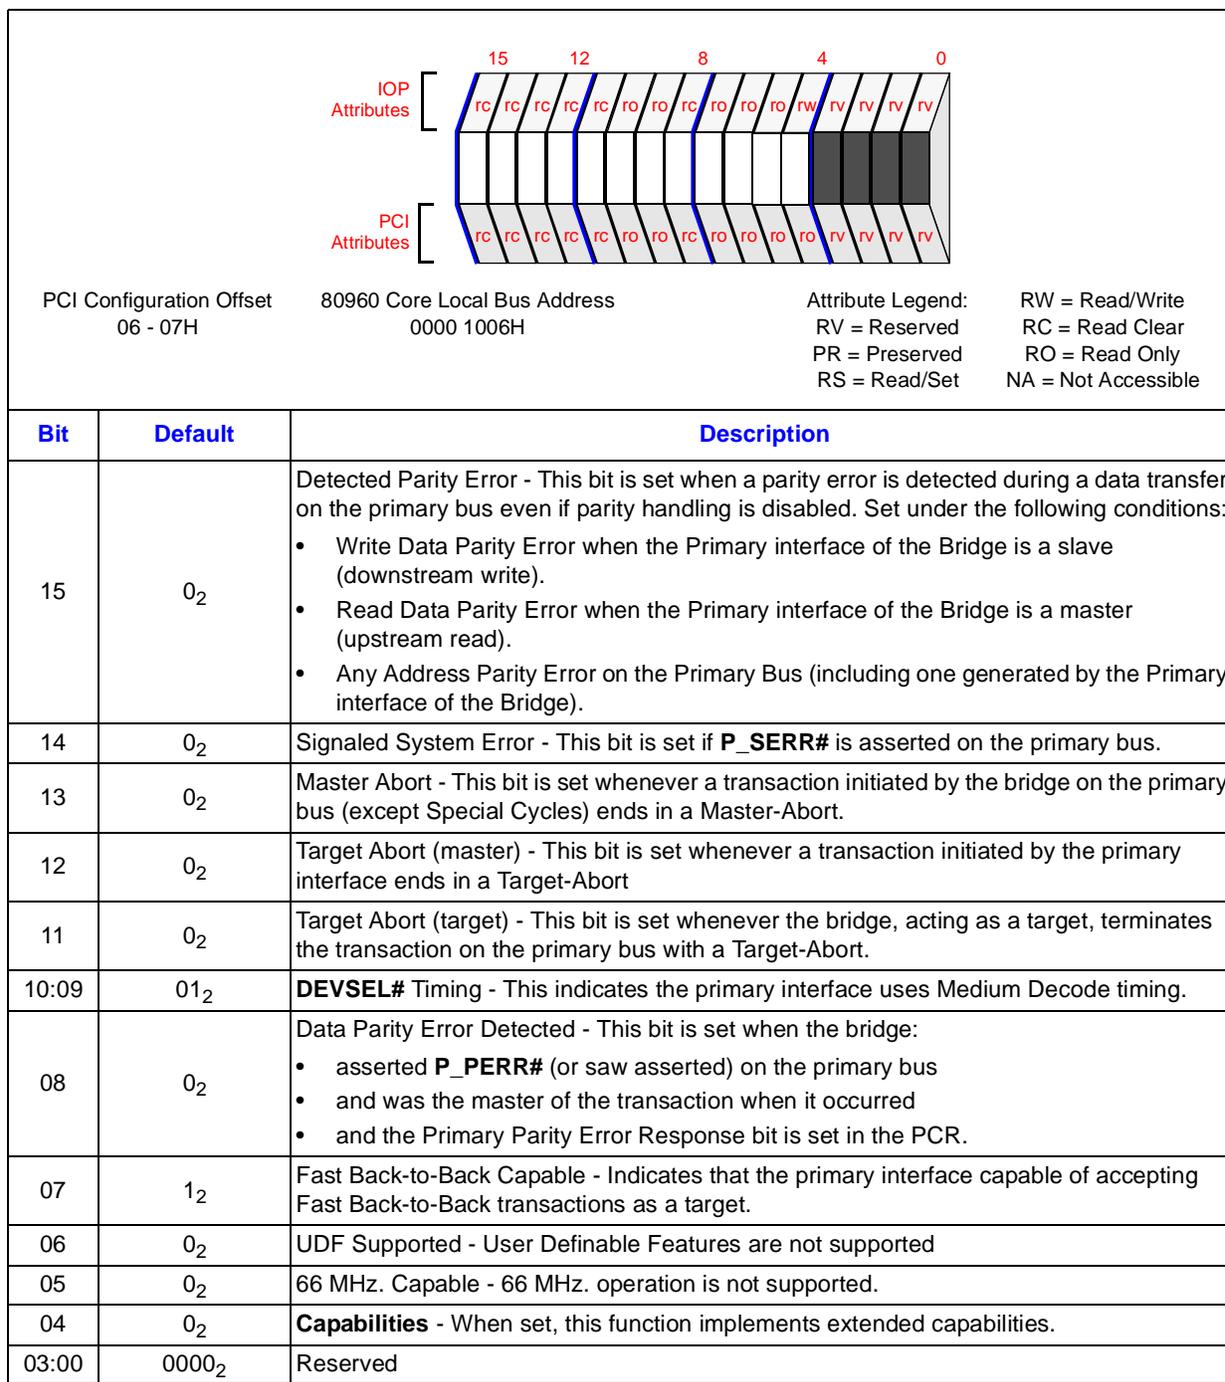
**Issue:** Figure 14-12 has been changed.

Bit 04 of the PSR is no longer reserved. It is now the “capabilities” bit - when set it this bit indicates the presence of extended capabilities, such as PCI power management. It is off by default for compatibility with legacy designs.

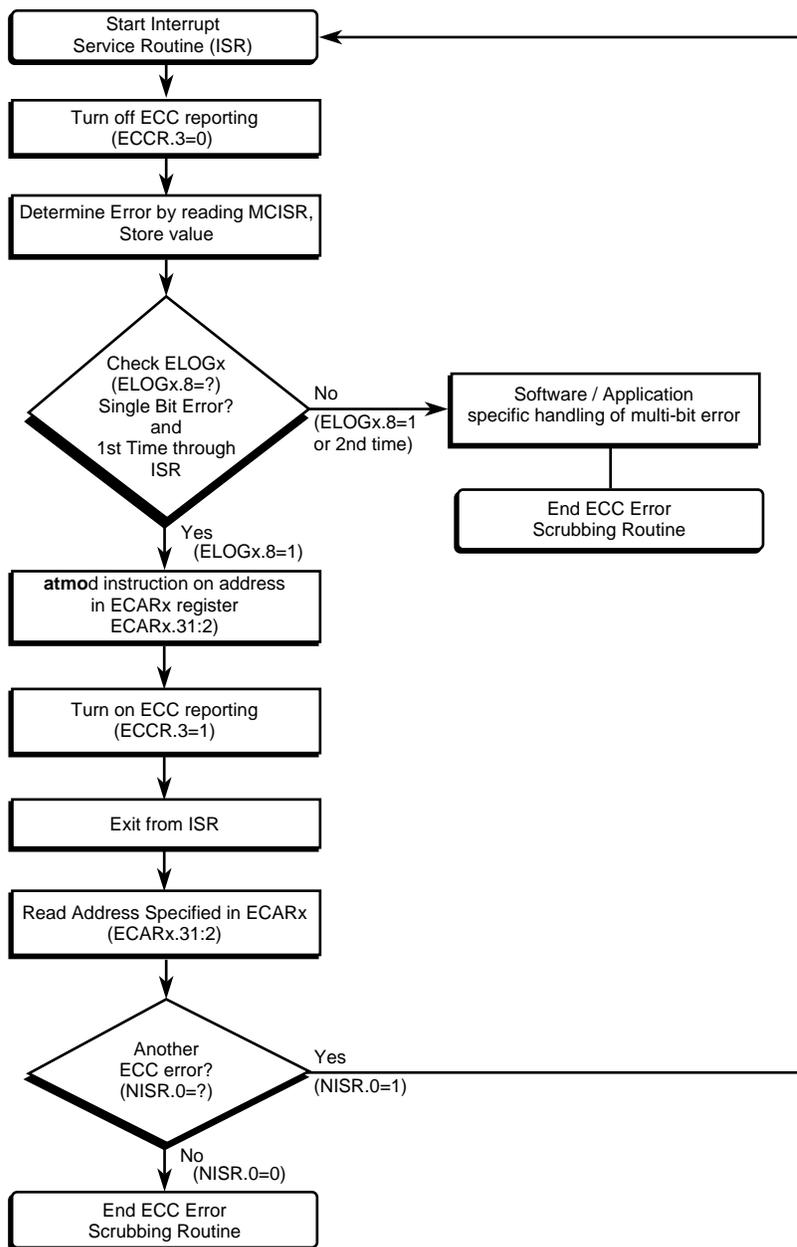
A7695-01

The diagram below is a flowchart version of the scrubbing routine.
